## Investigation of three SkV welds with defects in the head of the weld metal / Heavy reactivity of Thermit®-portions

### Untersuchungsbericht / Investigation Report

- A 43 / 13 -

22 03 000 (T-080-13)

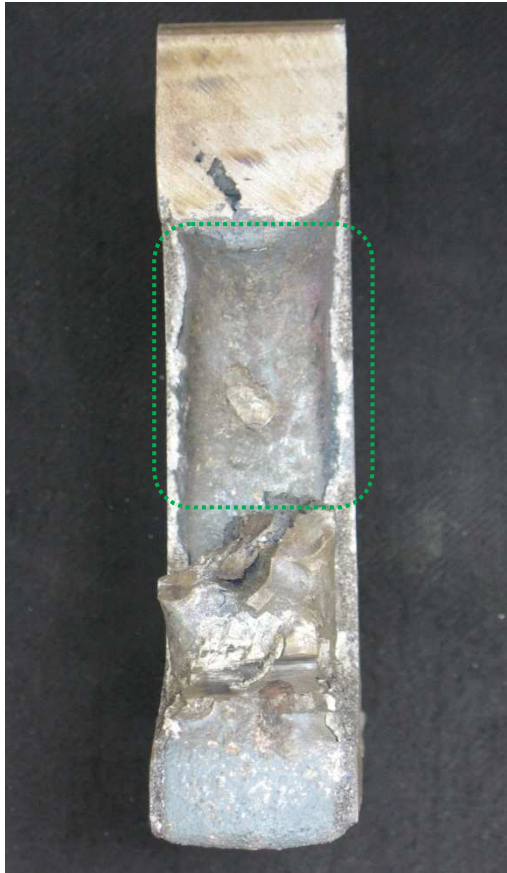
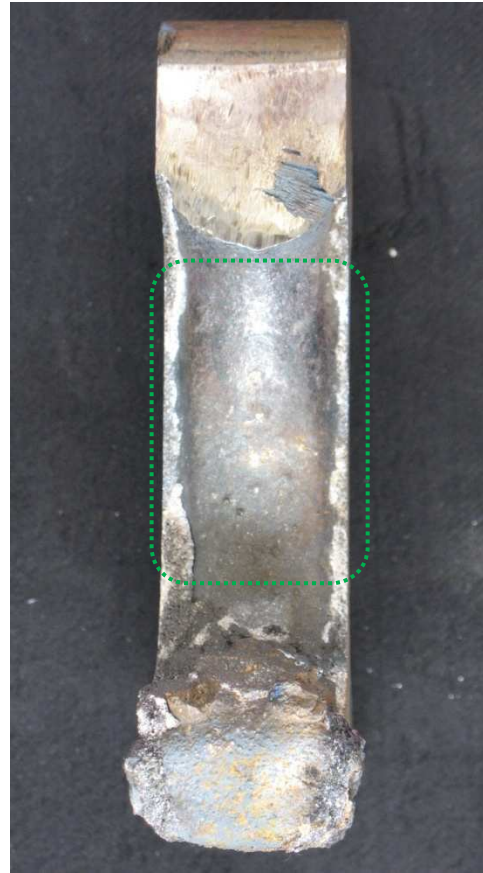
- Smooth weld collar surface in the web area (see Figures S1-3 and S1-4, green mark),
- Deformed riser at the foot riser window section (see Figures S1-9 and S1-10),
- One riser did not break of at the foot riser window due to the deformation of the riser,
- Oxidized, dendritic surface structure of hot-cracks in the head area (see Figures S1-7 and S1-8, red mark).

**Figure S1-3:** Side view 1

**Figure S1-4:** Side view 2

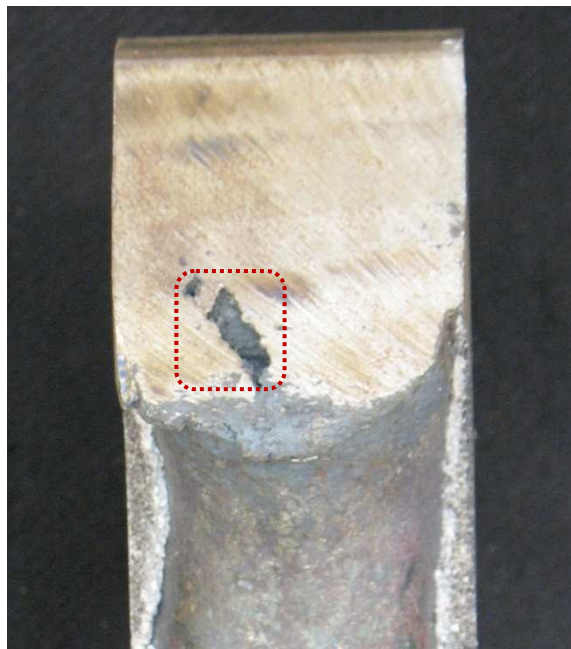
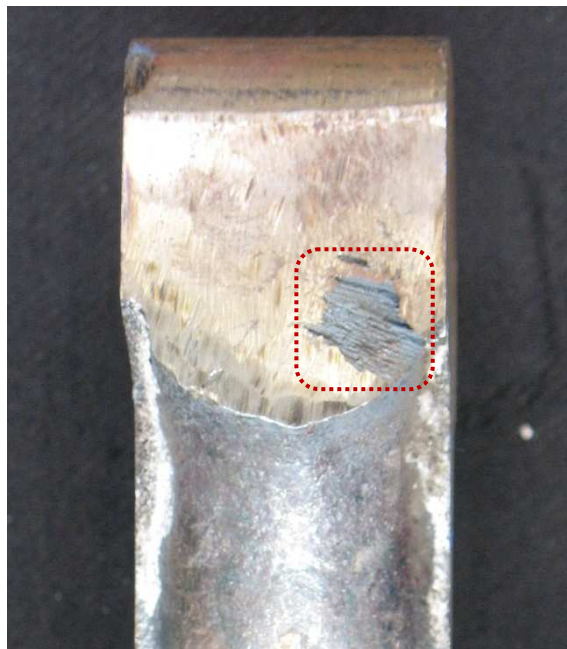
**Figure S1-7:** Detail – Side view 1

**Figure S1-8:** Detail – Side view 2

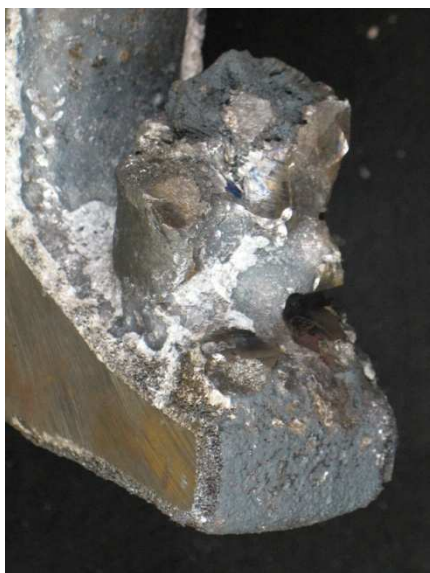
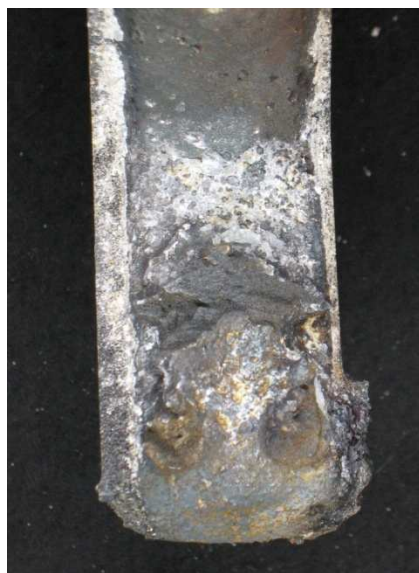
**Figure S1-9:** Detail - View on  
foot riser window section 1

**Figure S1-10:** Detail - View on  
foot riser window section 2

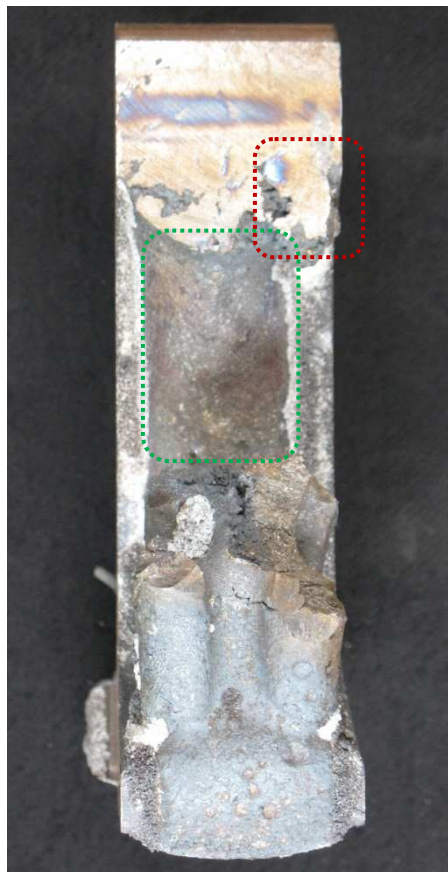
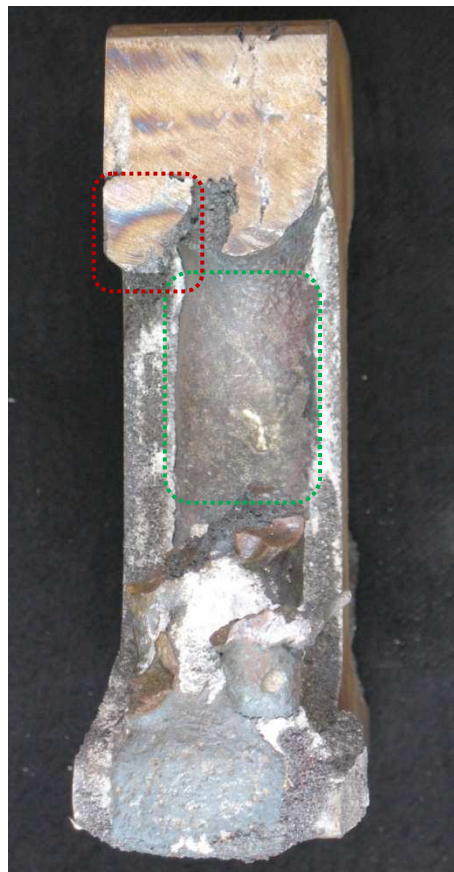
- Smooth and deformed weld collar surface in the web area (see Figures S2-3 and S2-4, green mark),
- Deformed riser at the foot riser window section (see Figures S2-1 to S2-4 and S2-10),
- The risers did not break off at the foot riser window due to the deformation of the risers,
- Oxidized, dendritic surface structure of hot-cracks in the head area (see Figures S2-7 and S2-8, red mark),
- Weld metal displacement at the outer head area (see Figures S2-3 and S2-4, red mark),
- Hot-crack structures with oxidized, dendritic surface on the running surface, gauge corner region and gauge face (see Figure S2-9),
- Cavities in the underfoot collar (max. Ø: 13 mm, max. depth: 5 mm, see Figure S2-6).

**Figure S2-3:** Side view 1

**Figure S2-4:** Side view 2

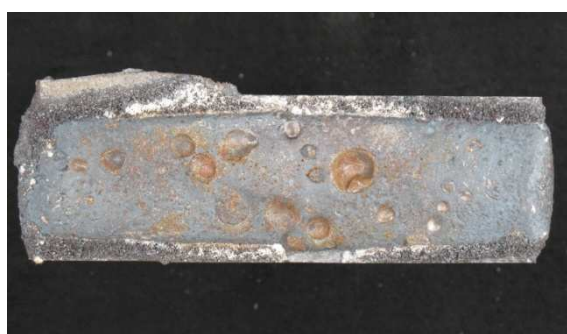
**Figure S2-6:** Bottom view

The generation of cavities in the underfoot collar (S2) is most probably caused by the too intensive pre-heating. We see a correlation of increased heat input (pre-heating, liquid Thermit®-steel) to the characteristic of the mould material that will most likely have caused the cavities.

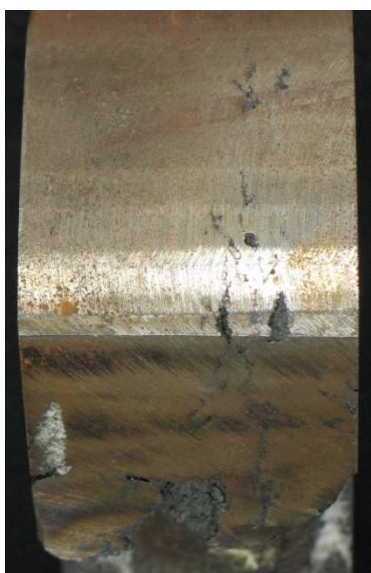
**Figure S2-9:** Detail – View on  
Gauge corner region

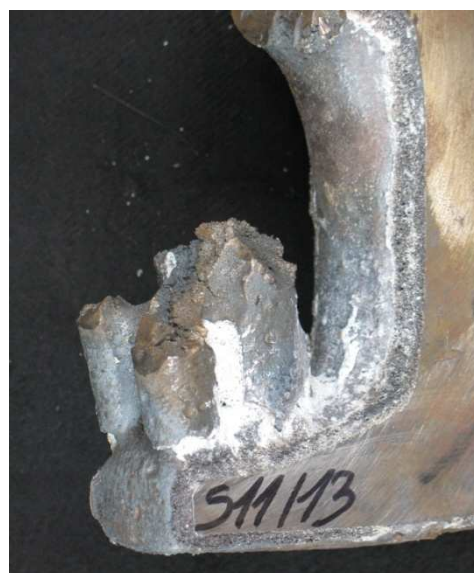
**Figure S2-10:** Detail – View on  
foot riser window section

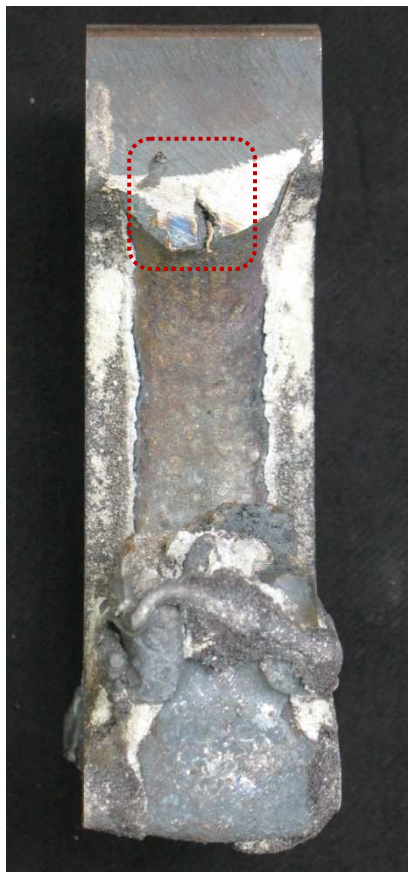
- Transition weld worn rail – new rail,
- Deformed riser at the foot riser window section (see Figures S3-7 and S3-8),
- One riser did not break of at the foot riser window due to the deformation of the riser,
- Oxidized, dendritic surface structure of hot-cracks in the outer head area (see Figures S3-3, red mark).

**Figure S3-3:** Side view 1

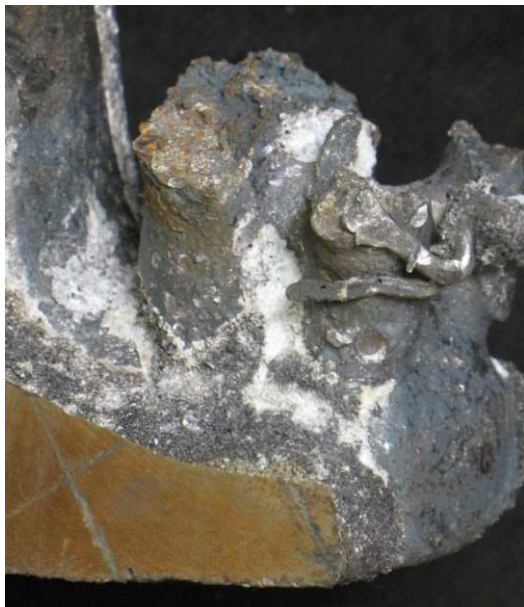
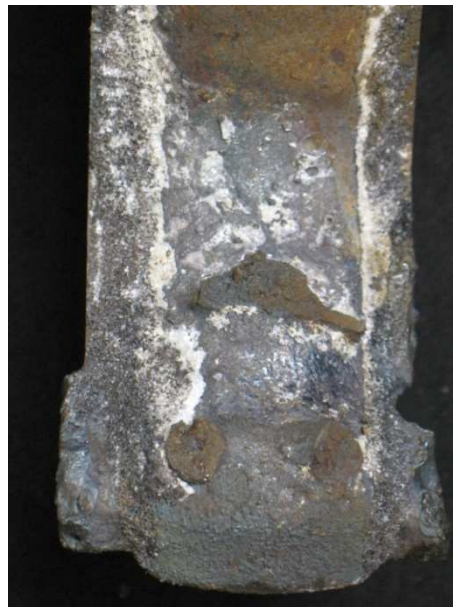
**Figure S3-7:** Detail - View on  
foot riser window section 1

**Figure S3-8:** Detail - View on  
foot riser window section 2

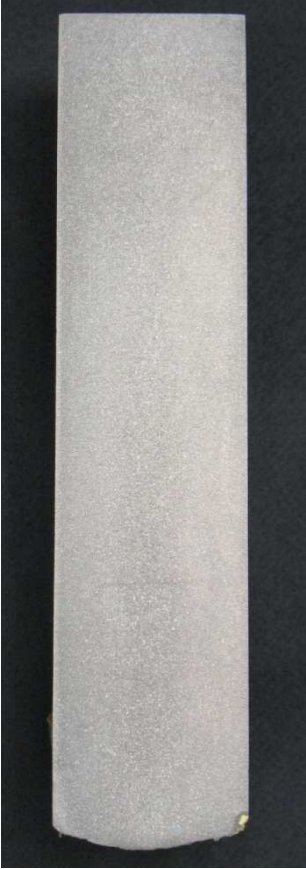
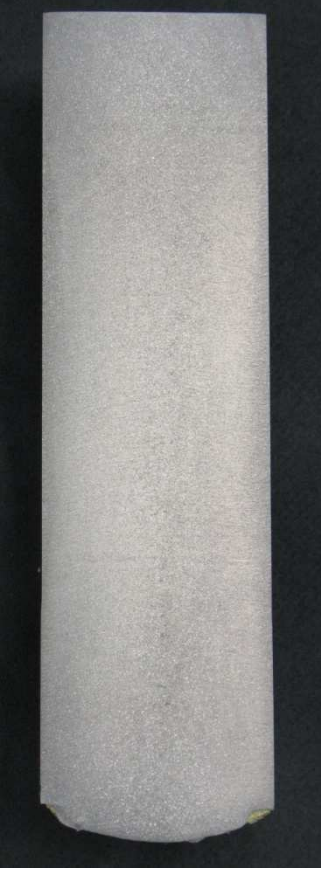
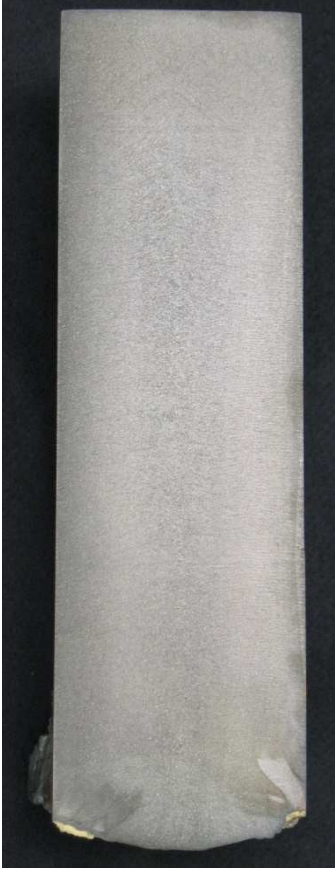
| <p><b>Figure S1-11:</b><br/>Longitudinal vertical section on centre line - S1<br/>Sample width: <math>\geq 41</math> mm</p> | <p><b>Figure S2-11:</b><br/>Longitudinal vertical section on centre line - S2<br/>Sample width: <math>\geq 48</math> mm</p> | <p><b>Figure S3-9:</b><br/>Longitudinal vertical section on centre line - S3<br/>Sample width: <math>\geq 52</math> mm</p> |

The fusion line (transition weld metal / HAZ) did not become visible in the longitudinal vertical section on the centre line on the etched samples.

Compared to this, the samples S2 and S3 indicate a significantly larger fusion width. S2 has a fusion width of  $\geq 48$  mm and S3 a fusion width of  $\geq 52$  mm. These values are the determined sample widths in the plain of the longitudinal vertical section on the centre line. The minimal fusion widths in the plain of the longitudinal vertical section of the foot tips were determined with 45 mm (S2) and 43 mm (S3).

It was not possible to visualise the fusion line of the sample S1. Accordingly it was not possible to determine the dimension of the fusion zone of sample S1. The sample width is  $\geq 41$  mm in the plain of the longitudinal vertical section on the centre line.

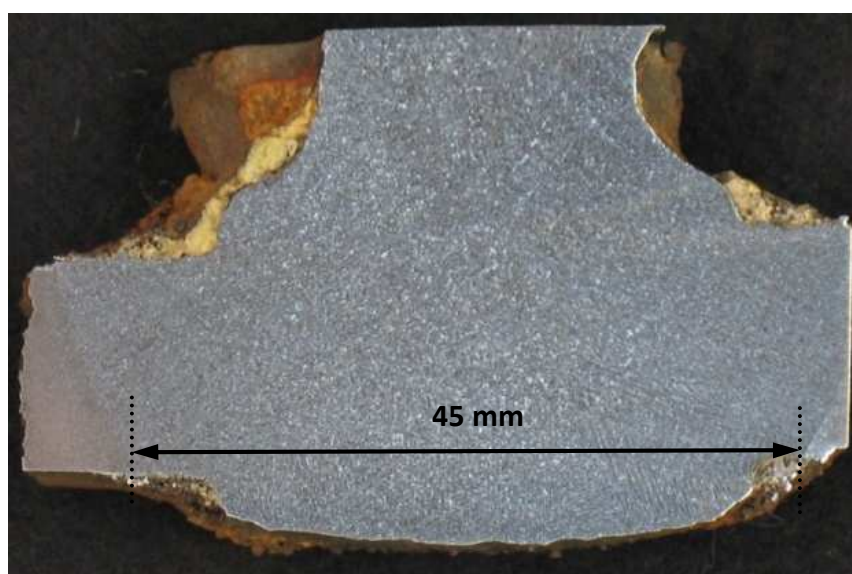
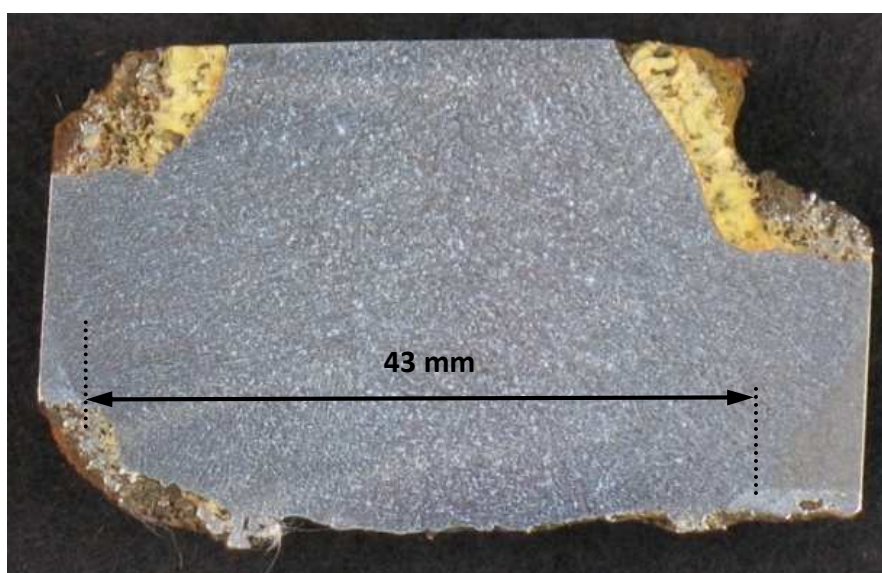
**Figure S2-12:** Longitudinal vertical section of one foot tip - S2

**Figure S3-10:** Longitudinal vertical section of one foot tip – S3
