## **Developments in Rail Metallurgy & Rail Welding**

**Swedish Welding Institute  
12<sup>th</sup> November 2009**

**Dr Jay Jaiswal  
Corus Rail**

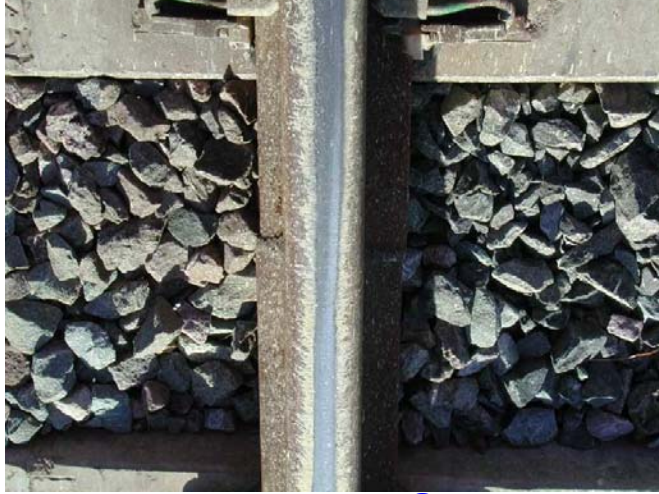
Running Band Deviation

- Running band deviation is considered undesirable for the effective management of Wheel-Rail Interface

- Some evidence that such running band deviations can contribute to the development of RCF
- Can ground transverse weld profile contribute to squat formation on the weld itself?
- However, factory FB welds are profile ground using dedicated “semi-automatic” grinders and longitudinal & lateral profile checked using laser. *How does the transverse weld profile compare to that of ground rail?*

- **Running Band Deviation at & following FB Welds**
  - Better profile could be achieved through milling rather than grinding
  - Reliable in-service degradation data needs to be obtained
- **Weld Breakage Risk**
  - Rail manufacturing flaws: No longer an issue with modern practices
  - Welding flaws: Better machine maintenance & operator awareness
  - Potential of fatigue failures: Fatigue strength much higher than in-service loading conditions, therefore, not an improvement target
- **In-service Degradation**
  - Weld “Cupping”: Improved resistance to wear across HAZ required
  - Weld Dips: Cause needs to be established through monitoring of in-service performance

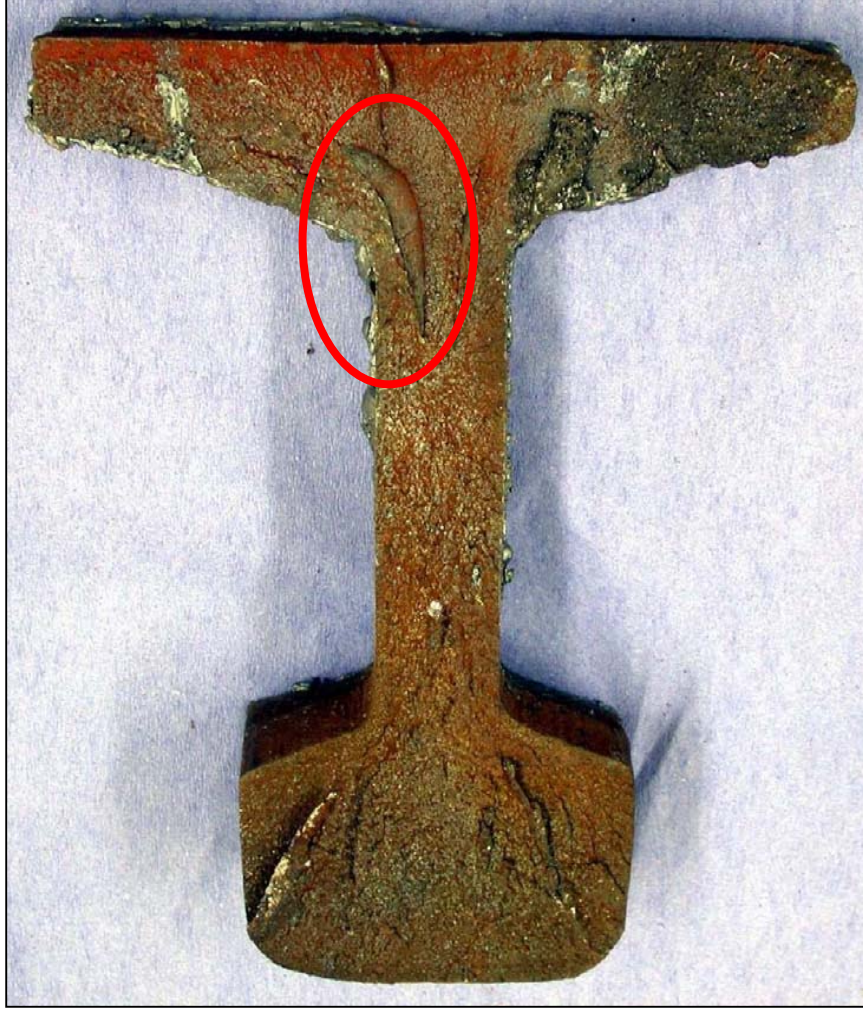
- Unusual fatigue crack on one side of web-foot transition radius
- Difficult to detect with conventional UST
- Oxide inclusions
- Parent rail defect (piping) - 1972 BS11:Normal Grade rail
- Modern rail manufacturing has eliminated such defects

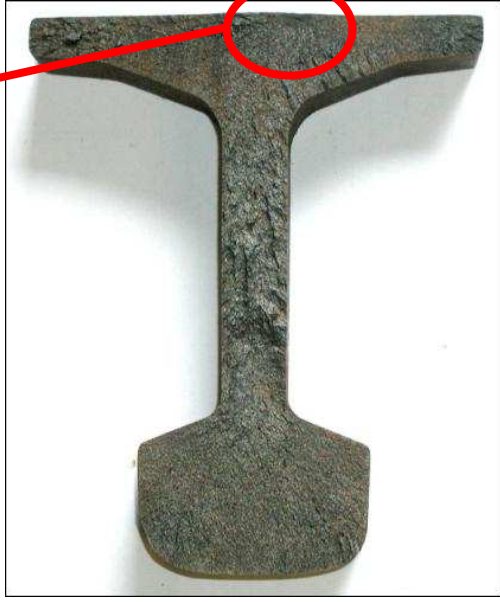
### Weld Failure from Die Burn

■ 1991 350HT rail

■ Die burn – pitting on bottom of foot

■ Also brittle microstructure (martensite and bainite)

- Better awareness of operators & maintenance of machine ensures such welds do not leave factory

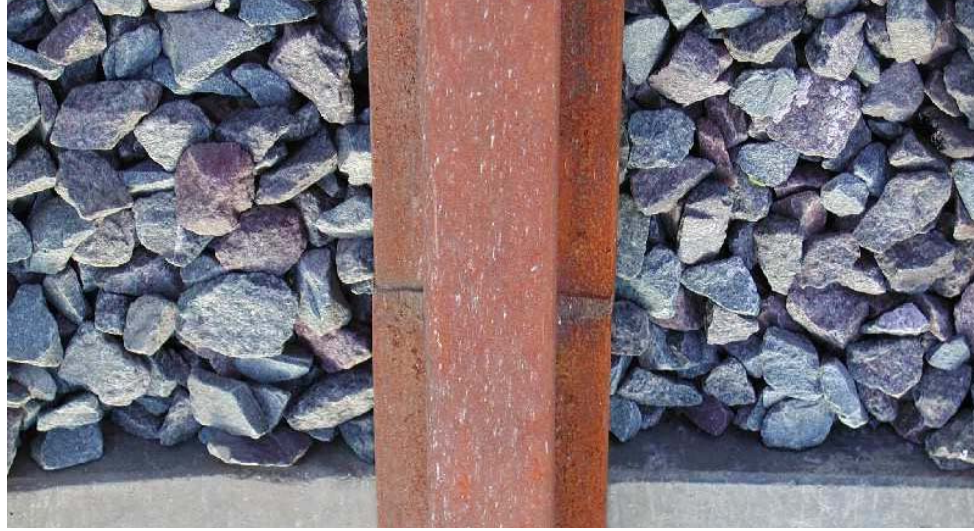
### Potential of Fatigue Failure? - Effect of Geometry

- Deviation from Straight at foot tips can give rise to stress raisers to lower fatigue resistance

- Where step arises from differences in rail dimensions, BSEN14587-1 2007 permits local dressing but does not specify how

- Care is taken to ensure dressing is to reduce stress raiser and not just compliance with specification limit

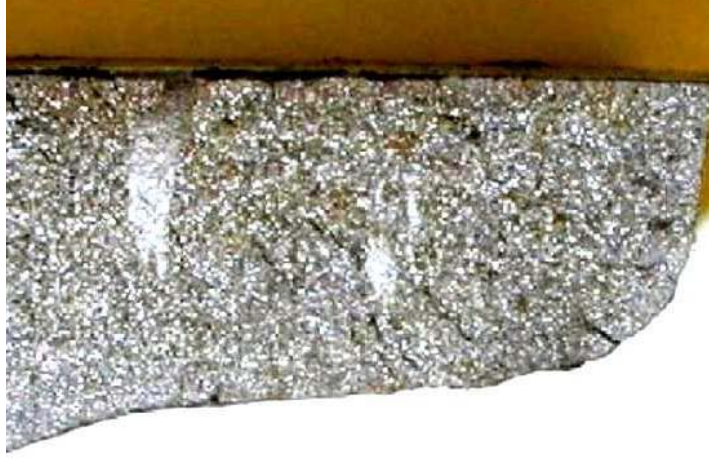
### Potential of Fatigue Failure - Effect of Flat Spots?

- The causes of Flat Spots in FB welding have been extensively researched
  - A key cause generally acknowledged is the failure to forge out large craters created by flashing
  - Specifications require recording of flat spots
  - However, clear lack of correlation between bend test loads & flat spot area. Observations suggest that surface breaking flat spots could lower bend test loads & could potentially increase probability of fatigue but no available evidence

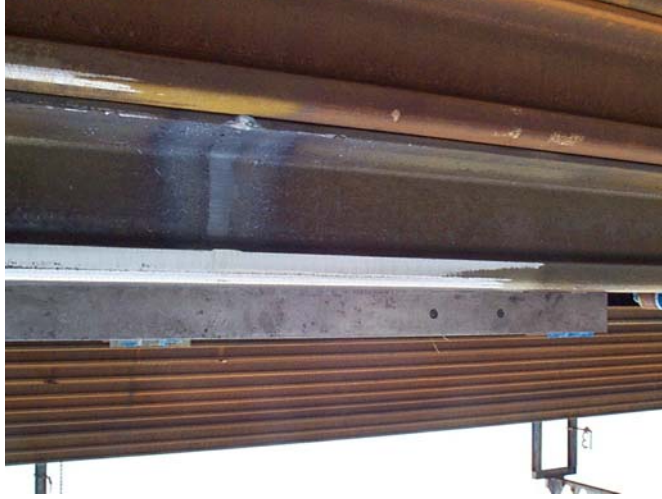
### In-service Degradation – “Cupping” & Dips

- Factory FB welds supplied to very tight specifications on vertical & lateral alignment but passage of wheels can lead to:

- Weld “Cupping”: caused by DIFFERENTIAL WEAR across the HAZ that can lead to increased track forces beyond the weld.

- Weld “Dip”: The loss of vertical alignment is lost over a much greater span than “cupping” – causes of dipping – many believe but little supporting data.

- ◆ Required improvement: Reduced gradient of hardness/wear resistance across HAZ

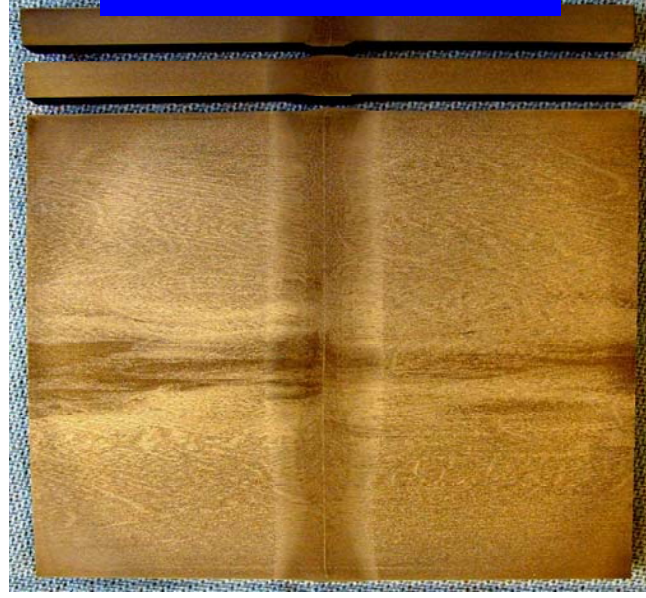
R350HT Std FB Weld

- HAZ width in standard FB welds is ~36mm but can be as high as 45mm
- Narrow HAZ welds have widths in the range 25-33 mm depending on composition being welded and HAZ hardness required

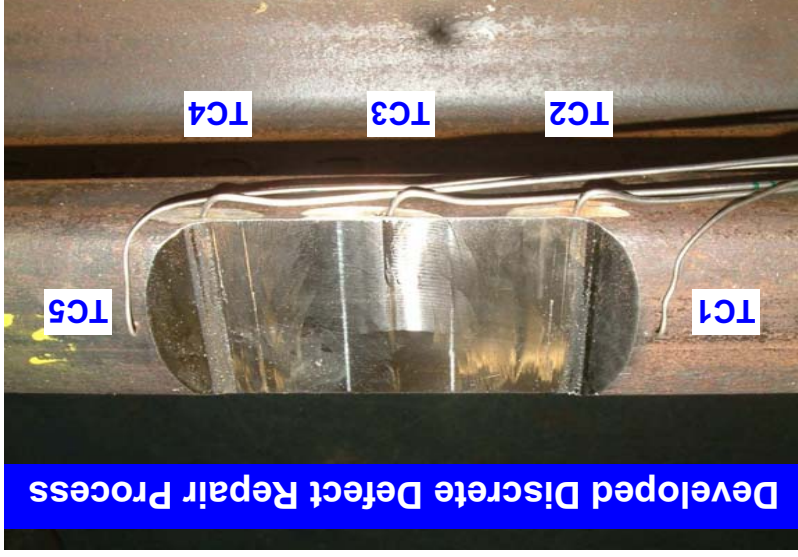
Instrumented Trial Samples

Developed Discrete Defect Repair Process

R260 MMA Rail Welding Trial - 30.3.2009, TC3

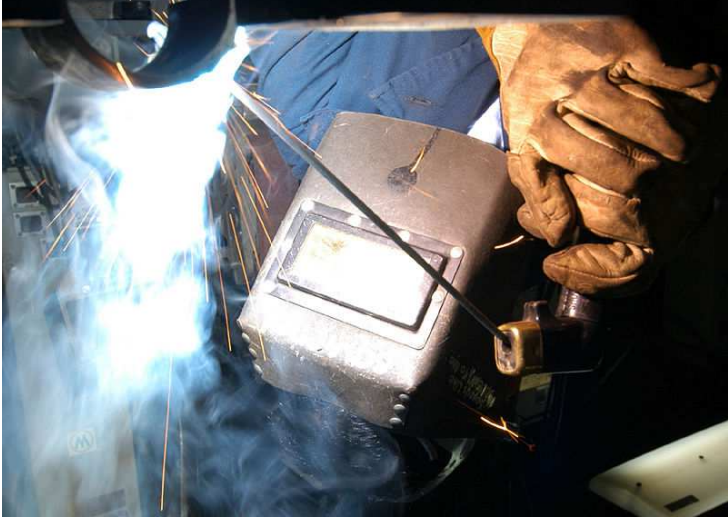
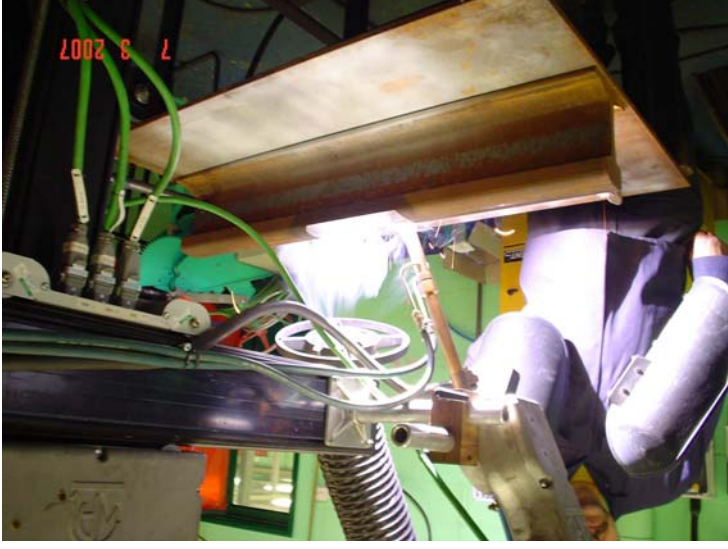
- The fastest cooling rate of 5.6°C/s is well below the critical rate for non-pearlitic transformation – Previous BR Research has concluded rates of >10°C/s result in martensite in the microstructure

- The lowest temperature achieved for each weld deposit is above 200°C/s – i.e. above  $M_s$  temperature of ~160 °C – Consequently there is no possibility of forming martensite even if the cooling rate was much faster

- The maximum temperatures & cooling rates closer to the fusion line are not expected to affect the overall integrity of the repair.

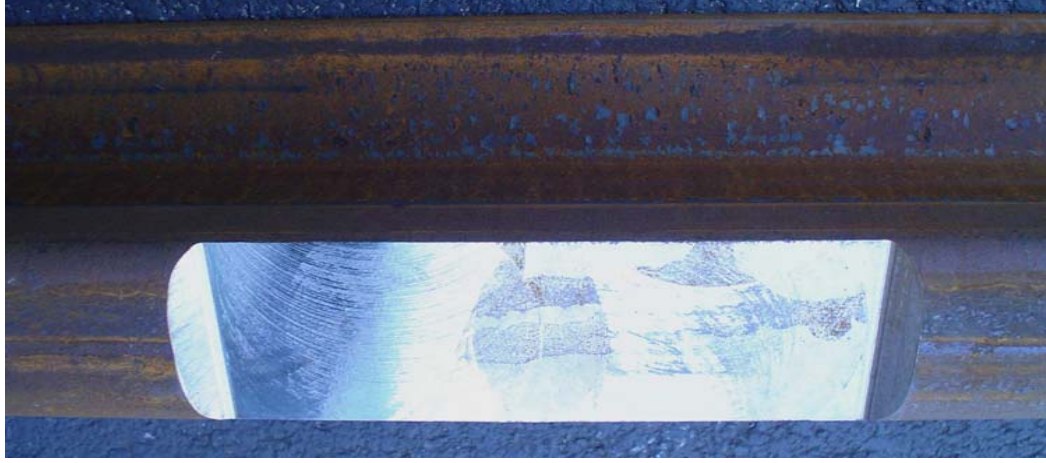
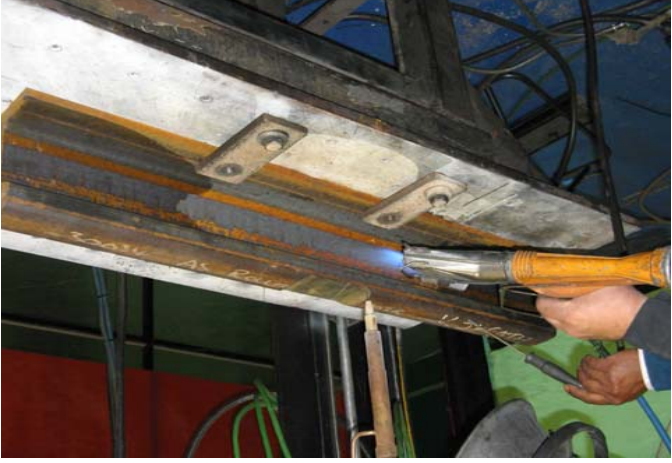
### ● Rail Milling:

- Choice of milling was based on the need for consistency, speed & automation
- Can be undertaken with a currently available portable milling unit:
  - ◆ a manually operated 3-axis milling machine that clamps onto the sides of the rail head.
  - ◆ 2kW motor and standard milling cutters between 16mm and 20mm diameter.
  - ◆ Fully portable - consists of two parts that easily clamp together (41kg + 62kg)
- Time to excavate defect (200mm x ~72mm x 10mm) = 15min
- Some modifications planned to make it compatible with subsequent welding

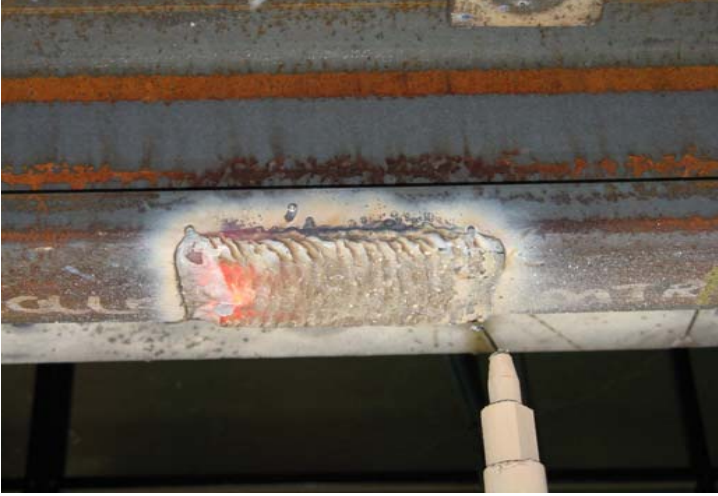
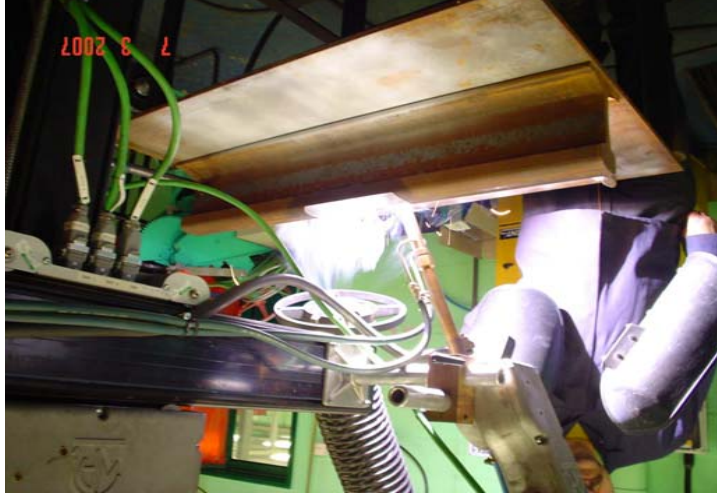
### ● Weld Repair:

- Semi- automatic Open Arc Welding employing Flux Cored Arc Wire
- Controlled patterned weave and energy input to minimise HAZ width
- Precise positioning of top layer to temper any hard microstructure at boundaries

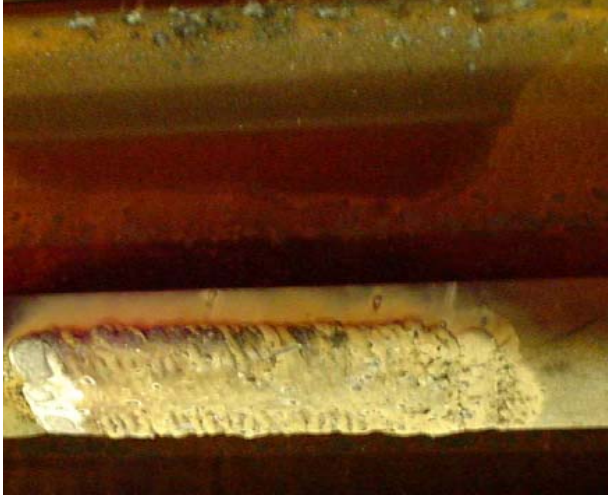
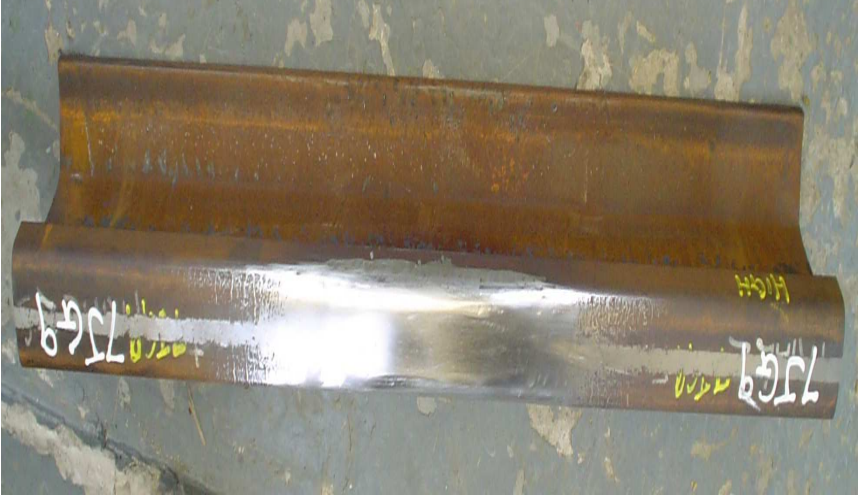
### ● Finish Profile Grinding:

- Currently undertaken using grinders in common use on railways
- Consideration being given to developing a milling tool

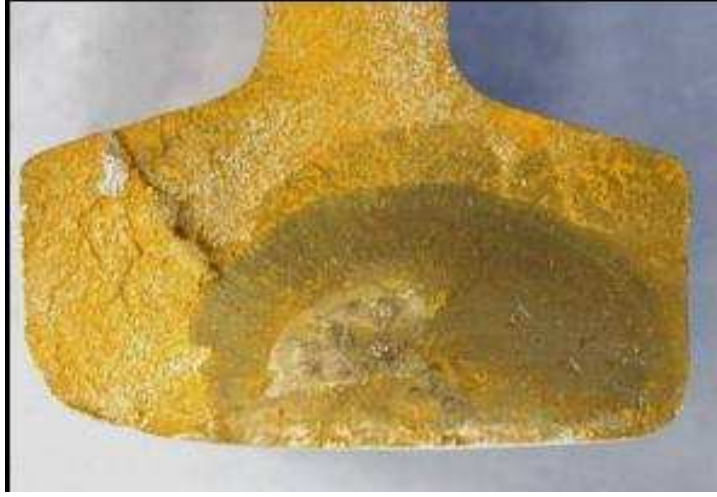
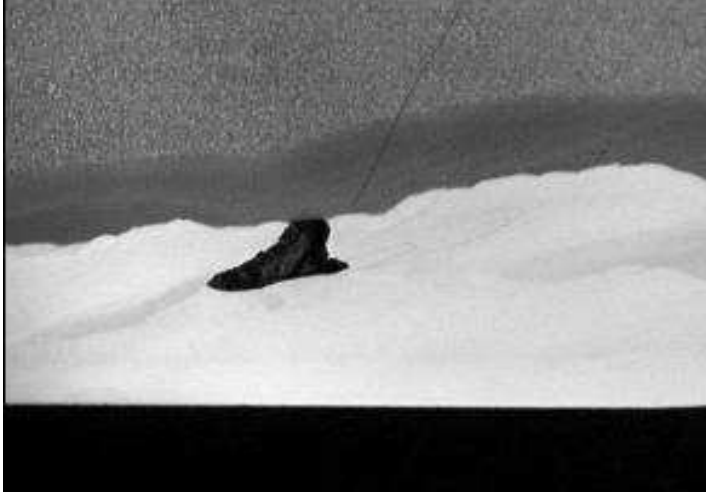
## Fatigue Failure Resistance – MMA Repair

- Failure mode often encountered with MMA repairs is fatigue initiated from flaws at the weld-parent metal interface.
- Such defects, like the classical Tache Ovale defects are not detected till they are sufficiently large leading to rail replacement.
- Statistical data for such failures is often inaccurate - mistaken for Tache Ovale or Vertical-Transverse breaks.

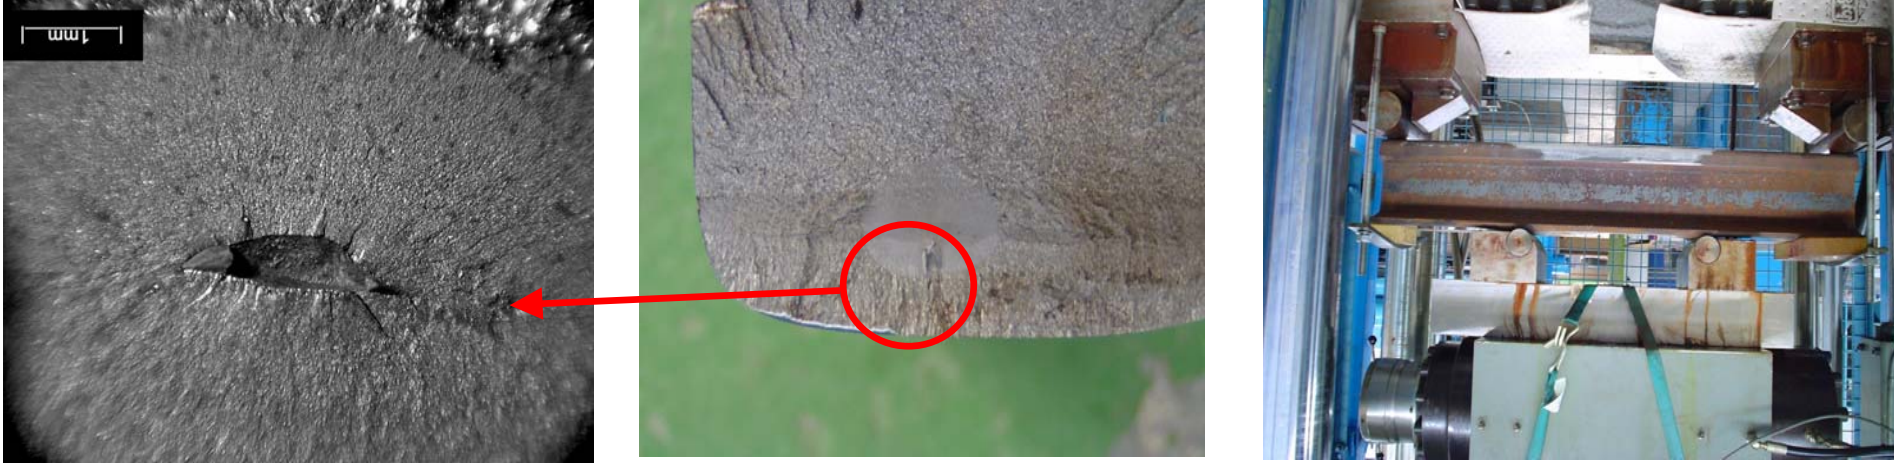
## Fatigue Failure Resistance – DDR Process

- Fatigue Resistance: 4-point Bending Fatigue test with Rail Head in tension
- Stress range = 3 times expected service load – passed 5 million cycles
- Further 4.3 million cycles at a stress range = ~8 times service load on same sample
- Failure in service extremely unlikely
