## INVESTIGATION OF THE QUALITY CHARACTERISTICS OF POLYAMIDE 12 PIPE WELDS

*Two research institutes, the German Plastics Center (SKZ) and TWI, examined the established quality tests for welds in PA-U12 pipes. The aim was to investigate to what extent the current quality criteria are transferable to PA-U12. This includes destructive tests such as the technological bending test as well as non-destructive tests like phased array ultrasonic testing.*

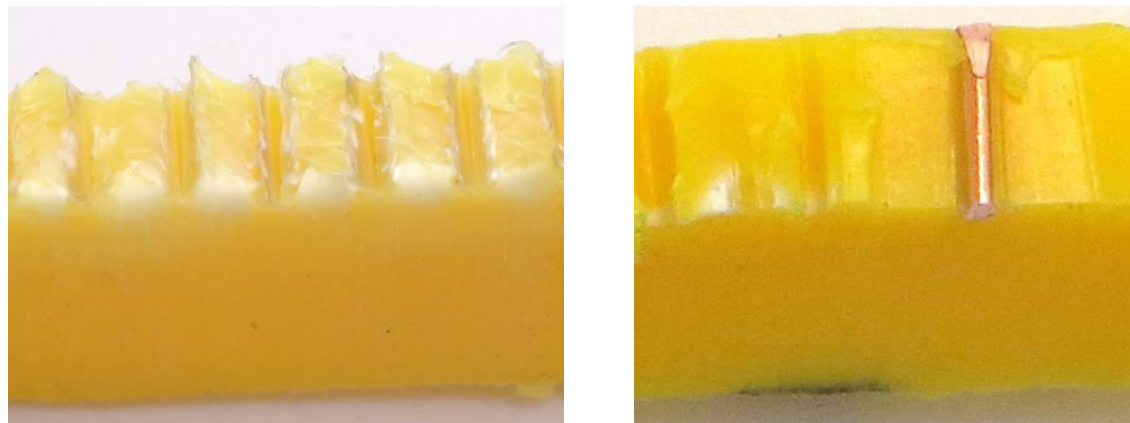
Figure 3: left: ductile area of the fracture surface after LSV testing, right: Brittle area of the fracture surface after LSV testing

Shear tests examine the quality of a welded joint produced by the HM process. The tests induce a fracture in the joint plane between pipe and socket, followed by an evaluation of the fracture pattern. The fracture surface that results from a shear test refers to the area between the first and last turn of the heating coil in each welding zone. Figure 3 shows an example of the ductile and brittle fracture areas. To evaluate the fracture surface, the proportion of brittle fracture and other defects such as voids was measured as a percentage of the total joining zone length (DVS 2203-1 supplement 4).
