## Investigation of three SkV welds with defects in the head of the weld metal / Heavy reactivity of Thermit®-portions

### Untersuchungsbericht / Investigation Report

- A 43 / 13 -

22 03 000 (T-080-13)

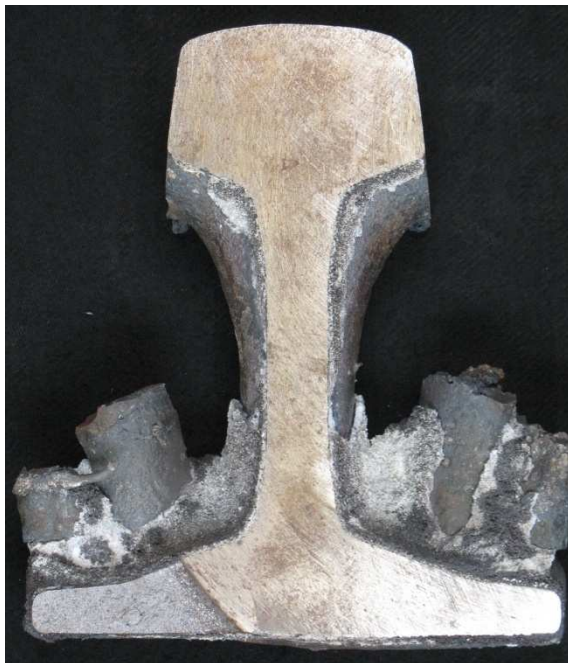
**Figure S2-1: Cut surface A**

- Smooth and deformed weld collar surface in the web area (see Figures S2-3 and S2-4, green mark),
- Deformed riser at the foot riser window section (see Figures S2-1 to S2-4 and S2-10),
- The risers did not break off at the foot riser window due to the deformation of the risers,
- Oxidized, dendritic surface structure of hot-cracks in the head area (see Figures S2-7 and S2-8, red mark),
- Weld metal displacement at the outer head area (see Figures S2-3 and S2-4, red mark),
- Hot-crack structures with oxidized, dendritic surface on the running surface, gauge corner region and gauge face (see Figure S2-9),
- Cavities in the underfoot collar (max. Ø: 13 mm, max. depth: 5 mm, see Figure S2-6).
